Van earthquakes (23 October 2011 and 9 November 2011) and performance of masonry and adobe structures

D. Güney

Division of Structure, Department of Architecture, Faculty of Architecture, Yildiz Technical University, 34469 Istanbul, Turkey

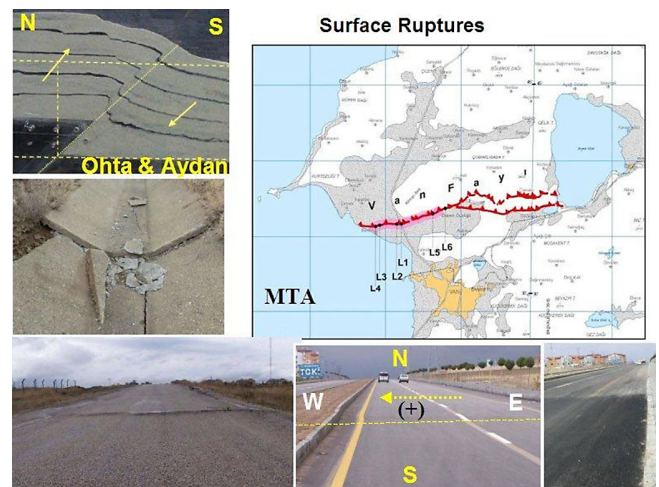
Fig. 3. Views of surface rupture along the fault trace (Emre et al., 2011).

Aydan (2007); there was no clear fault scarp on the ground surface as shown in Fig. 3. The earthquake originated at a depth ranging between 5–19 km depending upon the institutes, and it resulted from the movement of a 50-km-long and 20-km-wide thrust fault trending about E–W direction from Erçek Lake into Van Lake. The major energy release occurred within 20 s, although the total duration of the rupture was about 50 s.

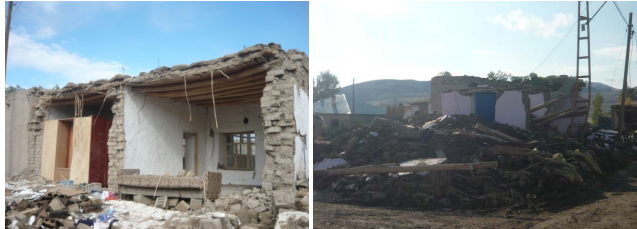
Fig. 8. Heavy roof with wooden beams of damaged and collapsed adobe building (Güveçli village, Van).

Although the bond beams on top of the walls are very crucial for seismic resistance, damaged masonry and adobe buildings did not have this type of beams on top of the walls. In addition, a heavy roof (filled with earth) with inadequate in-plane stiffness does not provide a rigid diaphragm effect, which is also one of the important reasons for this kind of failure (see Fig. 12). Because walls, bond beams and roofs were not properly connected to each other to transfer the seismic loads to each other, they performed beyond desired level since these infill walls behaved as free-standing walls.

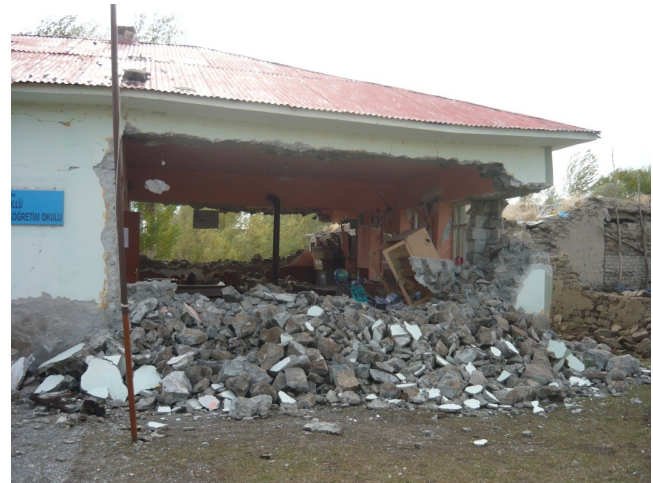
Fig. 9. Lack of interlocking between wall leaves in school building (Gölü village, Van).

The masonry walls built by stone were constructed as inner and outer leaves. The total thickness of them was generally about 50 cm. The unsupported length of the outer leaf of the masonry wall was increased two times because of lack of interlocking elements which is necessary to connect the inner and outer leaves to each other and transfer lateral load. But its effective thickness being reduced to half of the wall thickness results in a dramatic increase in the out-of-plane collapse risk since it is directly proportional to slenderness ratio of the wall. Figure 9 shows this kind of damage.

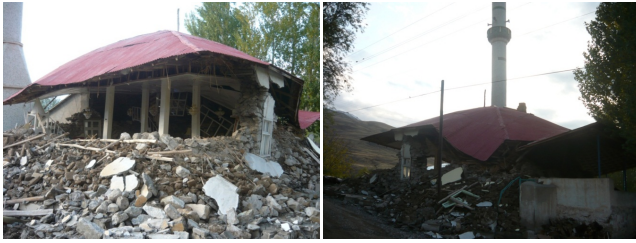
Fig. 10. No connection to partition walls of mosque (Dağönü village, Van).

damaged buildings had not been properly constructed to transfer horizontal forces resulting from earthquake. Figure 10 shows this type of wall collapse. In a building, the exterior walls should have proper connection with the partition walls. Nevertheless, the exterior walls of the most of the damaged buildings were found to be not connected to partition walls. Thus, the free span of the exterior wall was so large that it could not resist masonry wall out-of-plane failure.

Another common reason for damages in the buildings hit by earthquake is the inadequate distance between two windows. Irregular shape of the masonry units shown in Fig. 10 is also as vital as the inadequate wall length. In addition, the damage level in that wall could be higher if the bonding beams at mid-height and at the top of the walls were not damaged. The damage shown in Fig. 11 is an example for the damages caused by the inadequate distance between the opening and the building corner.

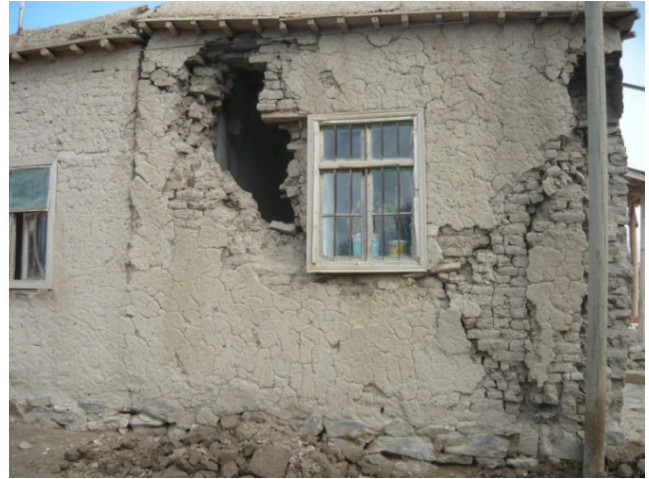
One of the most common reasons for partial or total collapse was incorrect location of the openings in the walls. Building codes for seismic design limit the distance between the two openings and the distance between the opening and corner of the walls (MPW, 1975, 1998, 2007), because the masonry and adobe walls are the only structural elements that bear lateral loads of the masonry buildings. According to Turkish Building Code (2007), the minimum distance between two openings should be at least 1 m and the minimum distance between an opening and a building corner should be 1.5 m.

Fig. 11. Wall opening close to the building corner (Güveçli village, Van).

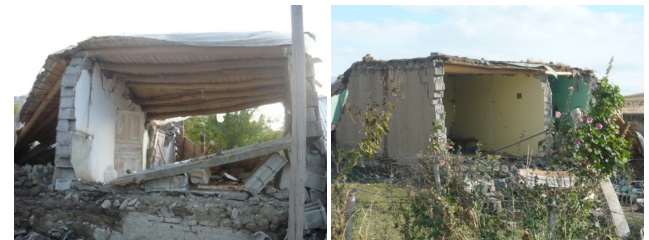
Fig. 12. Out-of-plane failure due to long span (Güveçli village, Van).
